QA-110

Walnut Grove

Centreville vicinity

INVENTORY FORM FOR STATE HISTORIC SITES SURVEY

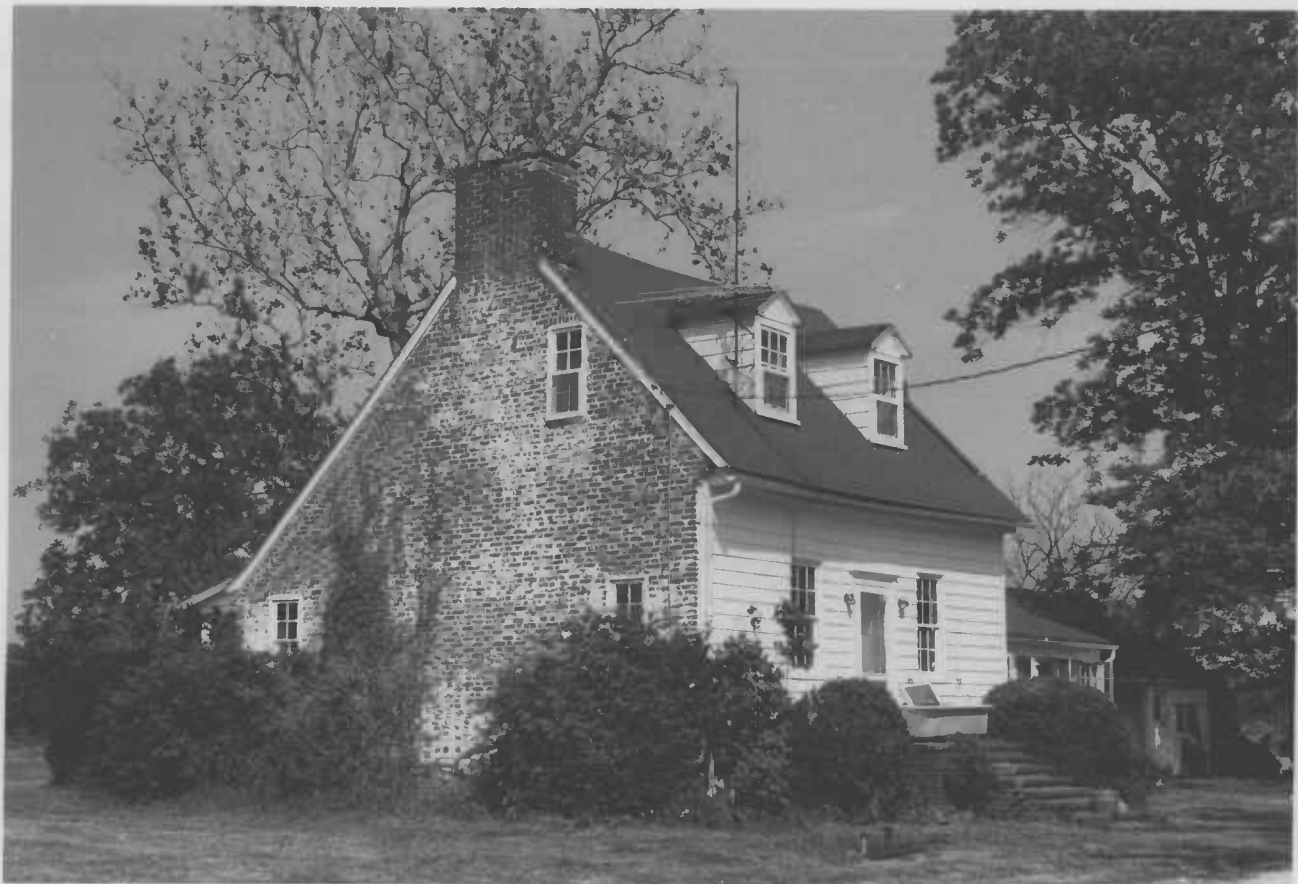
QA-110 Walnut Grove
Centreville vicinity
Orlando Ridout V, 1978 (MHT)
View from west

The principal facade faces southwest, toward Reed's Creek. There is a door in the center bay, flanked by a pair of six-over-six windows. These are shifted toward the central door, rather than falling in a more symmetrically balanced bay system. On the second floor, there are two six-over-six gable roof dormers. The exterior siding is asbestos shingle, while the eave is finished with a box cornice with crown mold and bed mold. The corner boards and rakeboards are modern replacements. The high brick foundation had several repairs and alterations. The westernmost corner has been rebuilt, and the two cellar window openings have

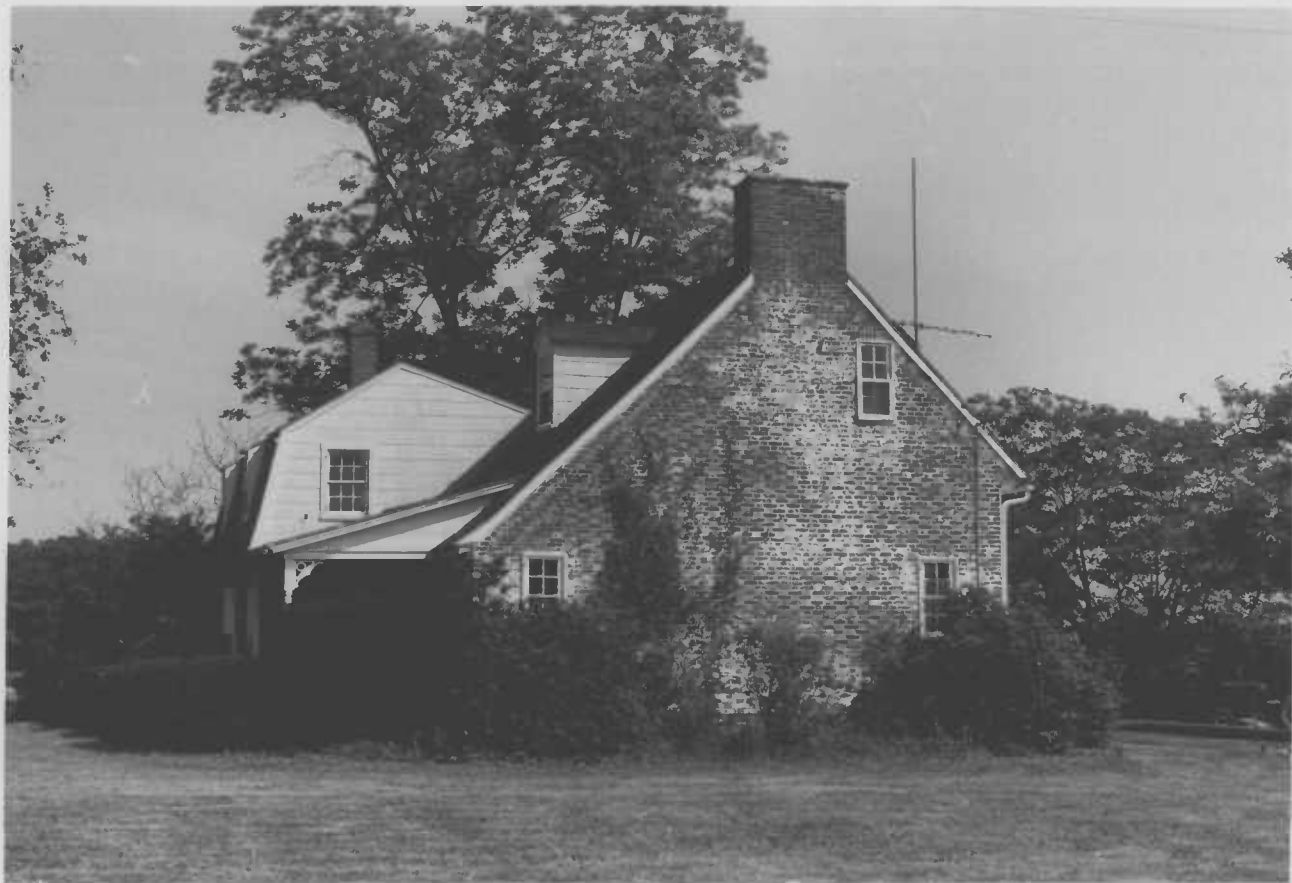
QA-110 Walnut Grove
Centreville vicinity
Orlando Ridout V, 1978 (MHT)
NW gable, camera facing SE

The northwest gable is brick, laid in Flemish bond with random glazed headers throughout and carefully laid glazed chevrons carried up the gable eaves. A single flush chimney at the apex of the roof serves all four of the interior fireplaces. Until recently the chimney cap displayed a plastered band of necking, but the cap is now gone, apparently knocked down in a storm. There are two tall, narrow, four-over-four windows on the first floor, one at each corner. On the second floor, a single four-over-four window is located to the right of the chimney. The lower window openings have queen closers on both jambs and are therefore original. The upper opening has queen closers only on the right jamb. The brickwork is somewhat rough, and it is possible this opening was originally smaller.

The foundation on this wall has also had considerable repair, and it is clear that several courses have been replaced altogether.

Of particular interest on this gable is the treatment of the eaves. The front and rear cornice is terminated

against a corbeled brick stop, quite similar to the eave detail at Pear Valley, an early 18th Century house in Northampton County, Virginia. Also of note is the distinct flare to the rear eave at Walnut Grove.
